Use Attainability Analysis

WBID 1373 Panther Creek

Submitted by
SES, Inc.

To
Missouri Department of Natural Resources
Water Protection Program

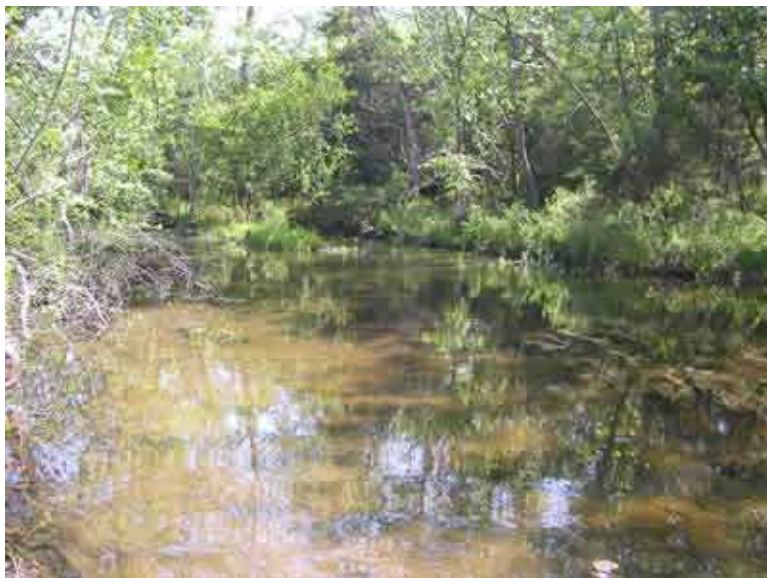
Site# 1 Photo ID# 43, Upstream

Upstream Photo 43 Downstream Photo 44

WBID # 1373 **Site #** 1
Mark # 21 **Dissolved Oxygen (ppm)** 7.2
Upstream Views Physical Dimensions: Is there any water present at this view? yes
 If so, is there an obvious current? yes

% of Channel Feature				
Riffle	25				
Run	0				
Pool	75

% Cobble	% Gravel	% Sand	% Silt
50	35	0	0
% Mud/Clay	% Bedrock		
0	15

Thick filamentous algae. Vegetation along banks. Floating algae scattered. Algae on rocks.

Odor	Sewage	<i>Musky</i>	Chemical	None	Other
Color	<i>Clear</i>	Green	Gray	Milky	Other
Bottom Deposit	Sludge	Solids	Fine Sed.	None	<i>Other: leaves, dead algae</i>
Surface Deposit	Oil	<i>Scum</i>	Foam	None	Other

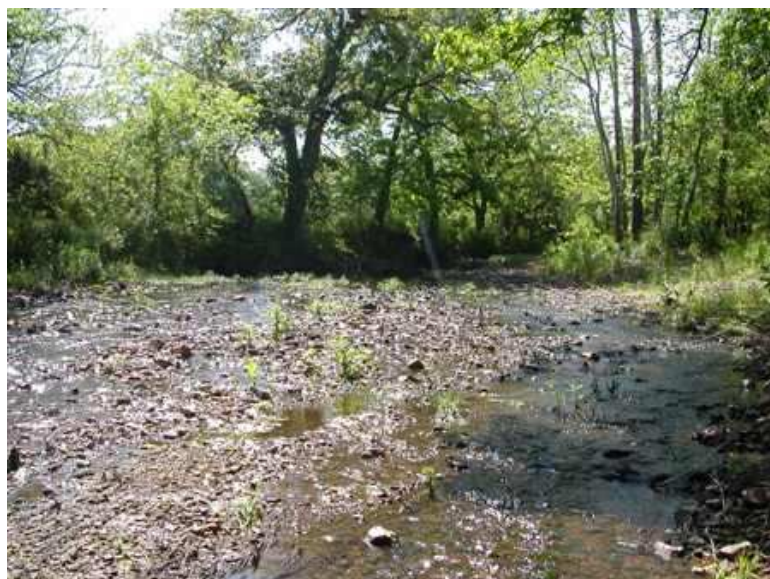
Site# 2 Photo ID# 45, Upstream

Upstream Photo 45 Downstream Photo 46

WBID # 1373 **Site #** 2
Mark # 22 **Dissolved Oxygen (ppm)** 9.7
Upstream Views Physical Dimensions: Is there any water present at this view? yes
 If so, is there an obvious current? yes

% of Channel Feature				
Riffle	27				
Run	0				
Pool	73

% Cobble	% Gravel	% Sand	% Silt
35	55	0	0
% Mud/Clay	% Bedrock		
0	10

Water grasses. Filamentous algae in riffles and shallow pools. Algae on rocks. No floating algae.
 Vegetation along banks

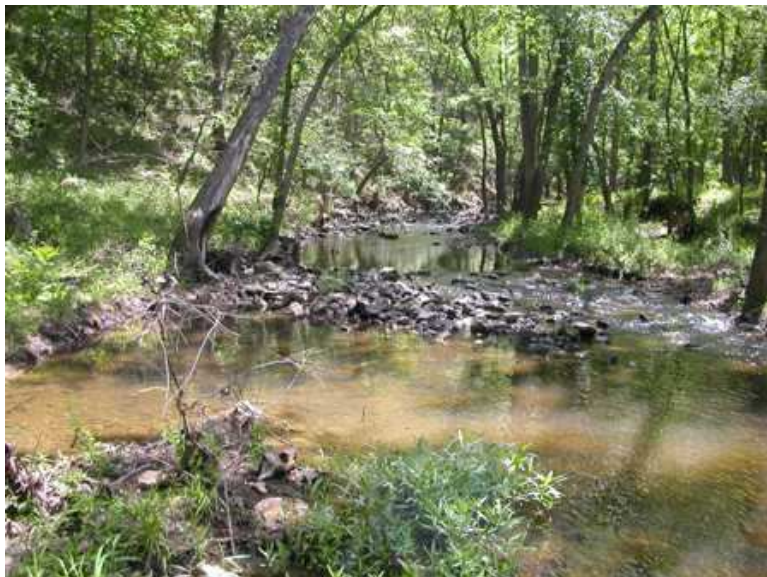
Site# 3 Photo ID# 48, Upstream

Upstream Photo 48 Downstream Photo 47

WBID # 1373 **Site #** 3
Mark # 23 **Dissolved Oxygen (ppm)** 11.7
Upstream Views Physical Dimensions: Is there any water present at this view? yes
 If so, is there an obvious current? yes

% of Channel Feature				
Riffle	19				
Run	0				
Pool	81

% Cobble	% Gravel	% Sand	% Silt
44	44	0	12
% Mud/Clay	% Bedrock		
0	0

Water grasses. Algae on rocks. Vegetation along banks. No floating algae.

Odor	Sewage	Musky	Chemical	None	Other
Color	Clear	Green	Gray	Milky	Other
Bottom Deposit	Sludge	Solids	Fine Sed.	None	Other: leaves, detritus
Surface Deposit	Oil	Scum	Foam	None	Other

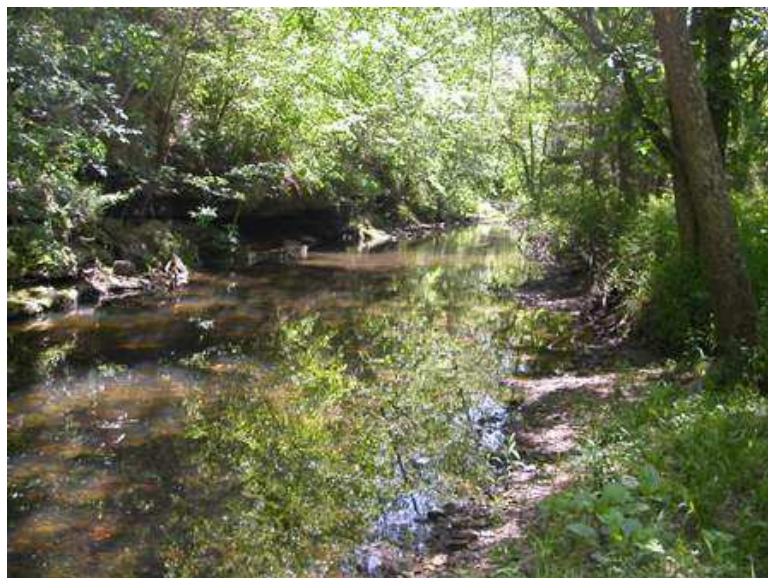
Site# 4 Photo ID# 50, Upstream

Upstream Photo 50 Downstream Photo 49

WBID # 1373 **Site #** 4
Mark # 24 **Dissolved Oxygen (ppm)** 9.5
Upstream Views Physical Dimensions: Is there any water present at this view? yes
 If so, is there an obvious current? yes

% of Channel Feature				
Riffle	10				
Run	0				
Pool	90

% Cobble	% Gravel	% Sand	% Silt
40	40	0	15
% Mud/Clay	% Bedrock		
0	5

No floating algae. Algae on rocks. Vegetation along banks. Filamentous algae in shallow areas.

Odor	Sewage	<i>Musky</i>	Chemical	None	Other
Color	<i>Clear</i>	Green	Gray	<i>Milky</i>	Other
Bottom Deposit	Sludge	Solids	Fine Sed.	None	<i>Other: leaves, detritus</i>
Surface Deposit	Oil	Scum	Foam	<i>None</i>	Other

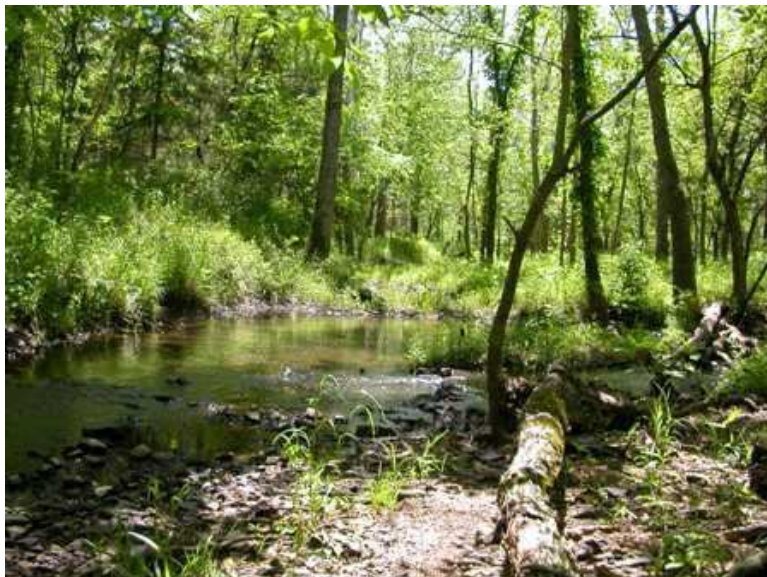
Site# 5 Photo ID# 51, Upstream

Upstream Photo 51 Downstream Photo 52

WBID # 1373 **Site #** 5
Mark # 25 **Dissolved Oxygen (ppm)** 10.1
Upstream Views Physical Dimensions: Is there any water present at this view? yes
 If so, is there an obvious current? yes

% of Channel Feature				
Riffle	27				
Run	0				
Pool	73

% Cobble	% Gravel	% Sand	% Silt
30	30	0	30
% Mud/Clay	% Bedrock		
0	10

Filamentous green algae in shallows. Water grasses by bridge. Vegetation along banks. No floating algae. Algae on rocks.

Odor	Sewage	Musky	Chemical	None	Other: Musky to None
Color	Clear	Green	Gray	Milky	Other
Bottom Deposit	Sludge	Solids	Fine Sed.	None	Other
Surface Deposit	Oil	Scum	Foam	None	Other

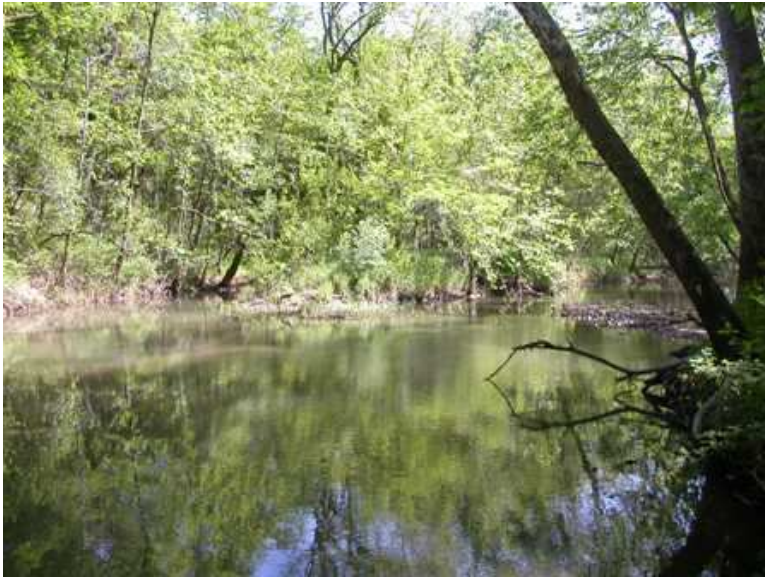
Site# 1 Photo ID# 33, Upstream

Upstream Photo 33 Downstream Photo 32

WBID # 1373 **Site #** 1
Mark # 16 **Dissolved Oxygen (ppm)** 10.8
Upstream Views Physical Dimensions: Is there any water present at this view? yes
 If so, is there an obvious current? yes

% of Channel Feature				
Riffle	20				
Run	0				
Pool	80

45% Cobble	50% Gravel	0% Sand	5% Silt
------------	------------	---------	---------

Filamentous green algae in riffles, no floating algae present, algae covering rocks, vegetation along banks

Odor	Sewage	Musky	Chemical	None	Other
Color	Clear	Green	Gray	Milky	Other: Milky Brown
Bottom Deposit	Sludge	Solids	Fine Sed.	None	Other: Leaves and detritus
Surface Deposit	Oil	Scum	Foam	None	Other

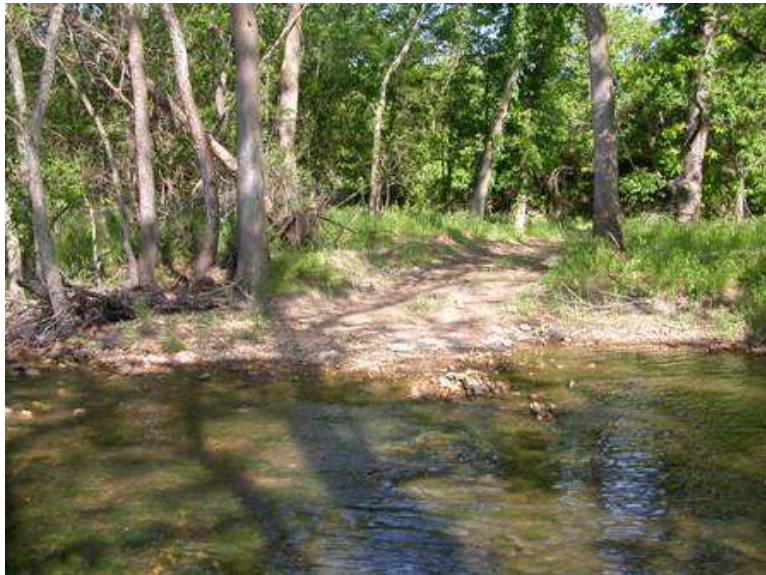
Site# 1 Photo ID# 31, Roads

Indications of Human Use Picture 31

Roads : (Picture 31)	Rope swings	Foot paths/prints	Dock/platform
Livestock Watering	RV/ATV Tracks	Camping Sites	Fire pit/ring
NPDES Discharge	Fishing Tackle	Other:
